**SUNSHINE COAST REGIONAL DISTRICT
COMMITTEE OF THE WHOLE
AGENDA**

SUBJECT: HOPKINS LANDING WATERWORKS DISTRICT CONVERSION OPTIONS

**Hopkins Landing Waterworks District
Water System Condition Assessment**

Appendix B – Site Photos

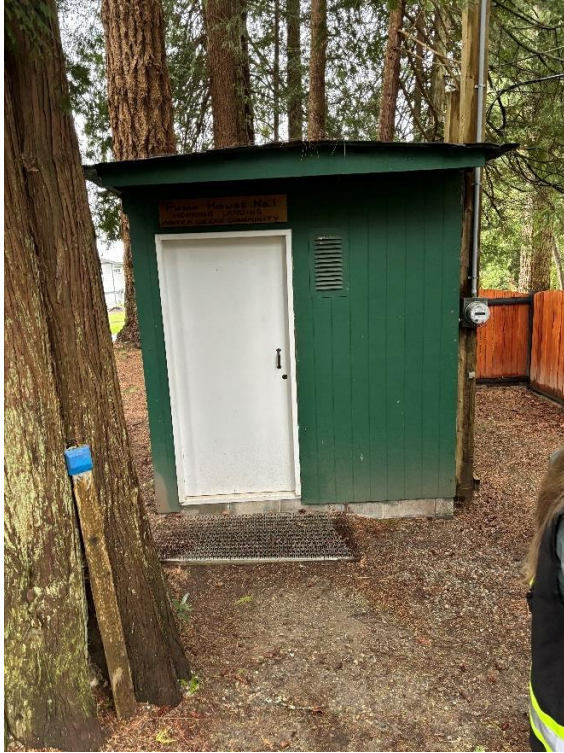
Figure 1 North Well House

The well house itself is in fair condition, with the original building standing with no signs of replacement. The well house is a concrete foundation surrounded by mulch, with a grate at the entrance. This is shown in Figure 2-2. It is set back from Burns Road, which is a single lane local road, with a narrow shoulder of mulch. Trees surround the well house, and with a fire hydrant installed outside the well house the site is restricted for space for maintenance vehicles. Approximately one maintenance vehicle would be able to be parked at site at a time, without hindering traffic and the surrounding houses. There is no outdoor lighting on site. There is no fence protecting the well house, but the door is kept locked, providing a measure of site security. The well house is a dropped floor single room consisting of the well head, vertical turbine, electrical controls, a gate valve, a check valve, and associated piping and appurtenances. The roof is comprised of asphalt shingles and is designed to be able to be lifted off for pump maintenance and removal. There is a base board heater installed, and one passive air vent that is sealed off. The room is insulated and does not appear to overheat in the summertime.

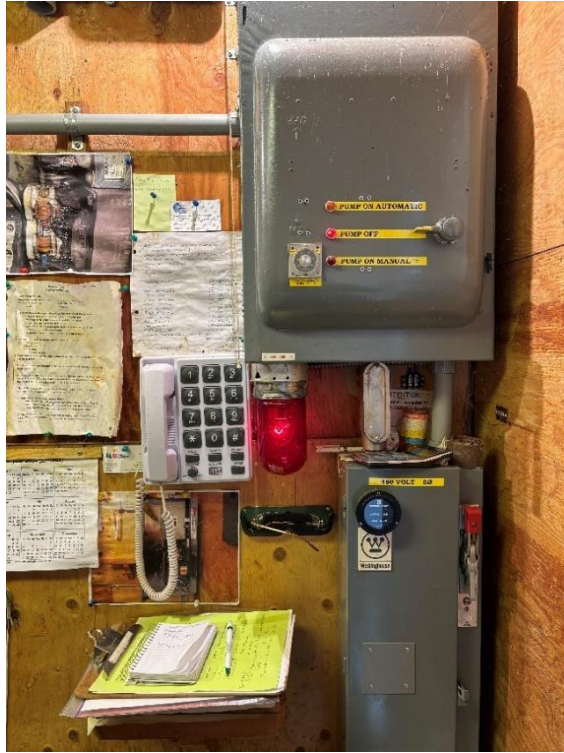
Figure 2 North Well House Interior

The well head is inside the well house, encased in concrete. It is unknown if the surface seal is intact, and no well identification plate could be found. The concrete encasement of the well head is raised, meaning any water pooling is directed away from the well head, though the building itself has no floor drain, leaving the water to pool on the floor. The well head is equipped with a vertical turbine pump.

The system contains a Cross the Line starter and is normally controlled by floats in the reservoir. There is no standby generator on site, and no backup power is available. All electrical equipment appears to be original, and while there are no signs of corrosion or obvious code violations, the equipment appears obsolete.

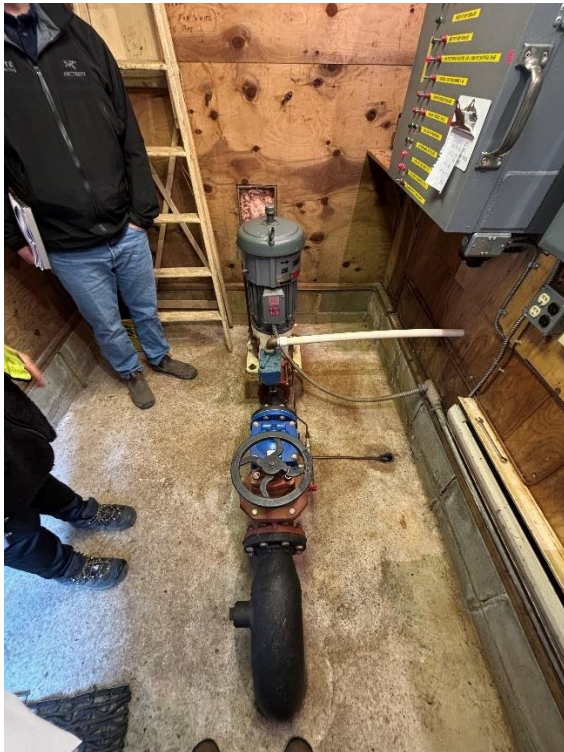
Figure 3 North Well House Piping Configuration

The well discharge piping consists of a 100 mm \emptyset steel discharge pipe with pressure gauge connections and an air release valve, which has a flange fitting connecting to a check valve. The check valve is a Valmatic Swing-Flex check valve, Model No. 504A. The check valve is flange connected to a Clow Gate Valve, also sized 100 mm \emptyset . The gate valve can be opened and closed with no sign of stress or resistance, and the pump was turned on to run during the condition assessment. The check valve appeared to operate as required, with no cavitation noises or vibrations apparent during the pump run. The gate valve is flanged to a welded steel reducer, upsizing the pipe into a 150 mm \emptyset bend, directing the discharge piping below ground. There are no signs of corrosion on any of the piping and equipment, and while the system is dated, it is all in good condition.

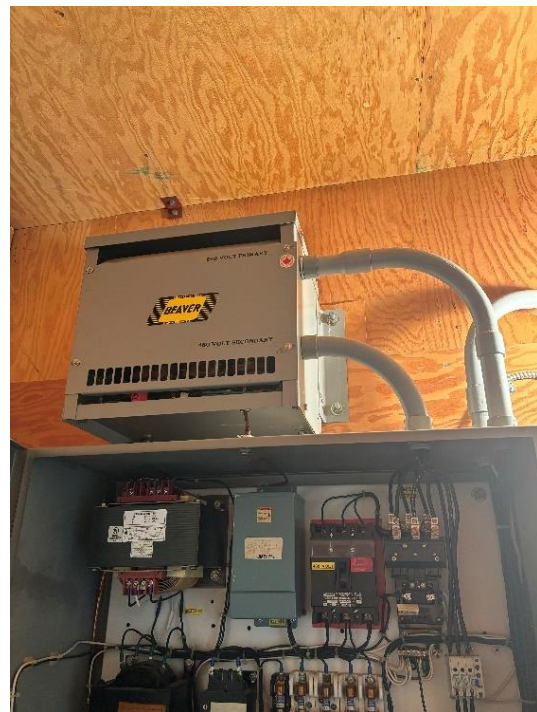
Figure 8 South Well House Electrical

The motor and power cables are not continuous from within well to within the kiosk, the receptacles are not ground fault interrupters (GFI), and the pump is not equipped with an amp meter. However, there seems to be no obvious code violations. The pump is equipped with an hour runtime meter. Like the North Well House, there appears to be no signs of corrosion, just obsolete electrical equipment.

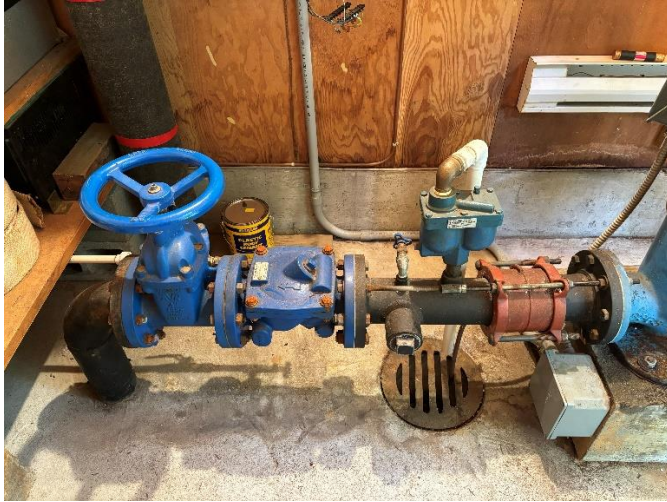
Figure 9 South Well House Piping

No cavitation noises were made apparent during the pump run. A slight bend is visible in the aboveground piping however it is within tolerance. There are no signs of corrosion on any of the piping and equipment, and while the system is dated, it is all in good condition.

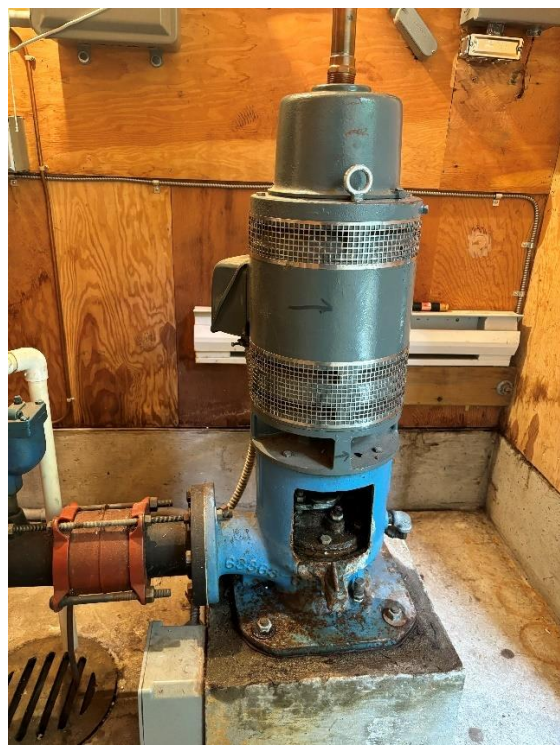
Figure 12 South Well House Pump

The well head appears to be in good condition and is encased in concrete. The encasement is in good condition and is raised above grade to direct water pooling away from the well head. The well head is sealed and equipped with a SIMFLO vertical turbine pump, Model No. SM6C-4 (Serial No. 104988).

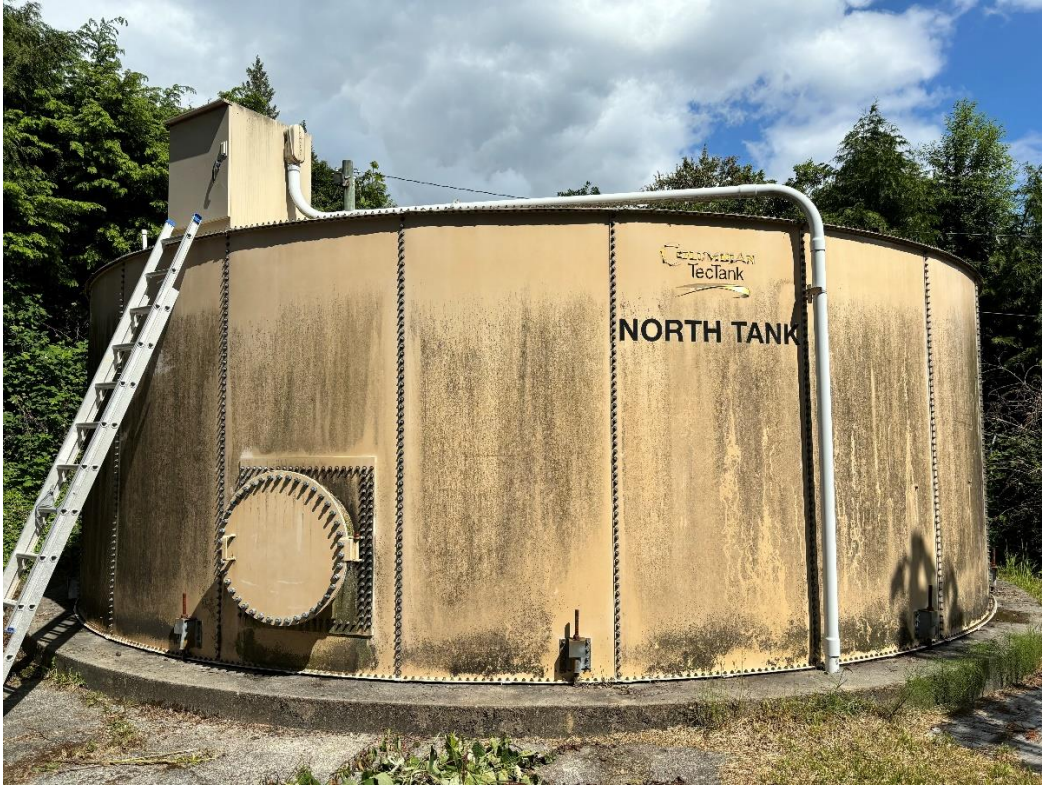
Figure 13 North Tank

The exterior of the tank is in good condition, with no visible signs of paint flaking or corrosion on the bolts. There is minor moss growth on the exterior, and small debris on the roof of the tank, but overall there is nothing concerning from a visual perspective. The valve chamber is in good repair, however a visual inspection of the chamber itself proves that moisture and organic material are freely entering the chamber, and the wooden cover is showing signs of rot due to the high presence of moisture.

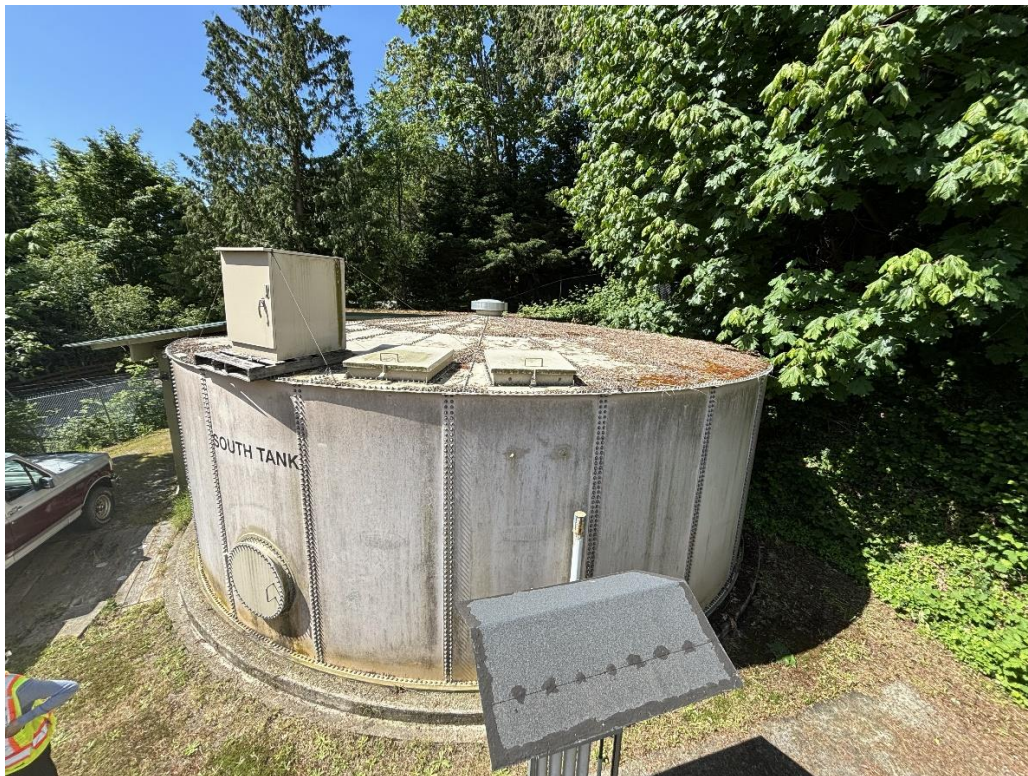
Figure 14 South Tank

The exterior of the tank shows signs of age and corrosion, with moss forming over the steel exterior. All bolts appear in good condition, with no signs of failure. The valve chamber is in good repair, however a visual inspection of the chamber itself proves that moisture and organic material are freely entering the chamber, and the wooden cover is showing signs of rot due to the high presence of moisture. The act of opening the tank is not easily done by one person, and the process of removing each individual plank of wood to access the chamber, then fitting them back may prove to be inefficient and potentially a safety issue if not correctly placed back.

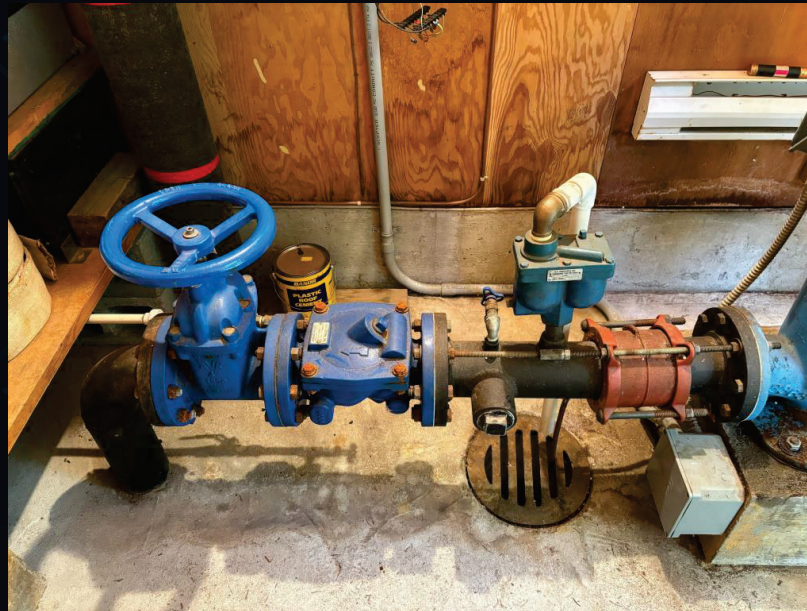
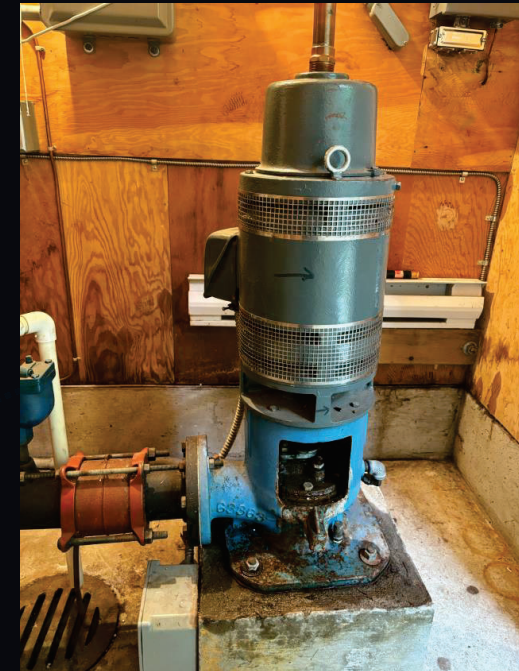
North Well Mechanics

- Water quality meets Canadian Water Drinking Guidelines
- Can supply about 24.6 L/s
- Aging infrastructure does not currently meet Groundwater Protection Regulations
