SUBJECT: HOPKINS LANDING WATERWORKS DISTRICT CONVERSION OPTIONS

**Hopkins Landing Waterworks District
Water System Condition Assessment**

Appendix B – Site Photos

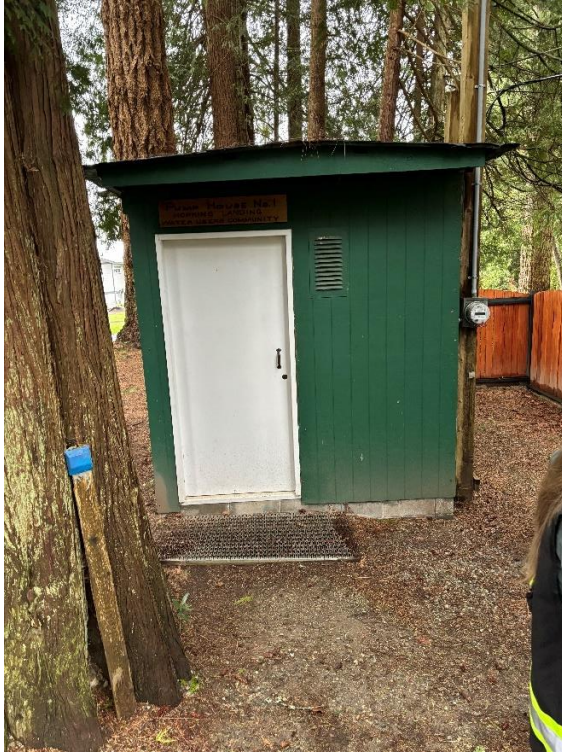
Figure 1 North Well House

The well house itself is in fair condition, with the original building standing with no signs of replacement. The well house is a concrete foundation surrounded by mulch, with a grate at the entrance. This is shown in Figure 2-2. It is set back from Burns Road, which is a single lane local road, with a narrow shoulder of mulch. Trees surround the well house, and with a fire hydrant installed outside the well house the site is restricted for space for maintenance vehicles. Approximately one maintenance vehicle would be able to be parked at site at a time, without hindering traffic and the surrounding houses. There is no outdoor lighting on site. There is no fence protecting the well house, but the door is kept locked, providing a measure of site security. The well house is a dropped floor single room consisting of the well head, vertical turbine, electrical controls, a gate valve, a check valve, and associated piping and appurtenances. The roof is comprised of asphalt shingles and is designed to be able to be lifted off for pump maintenance and removal. There is a base board heater installed, and one passive air vent that is sealed off. The room is insulated and does not appear to overheat in the summertime.

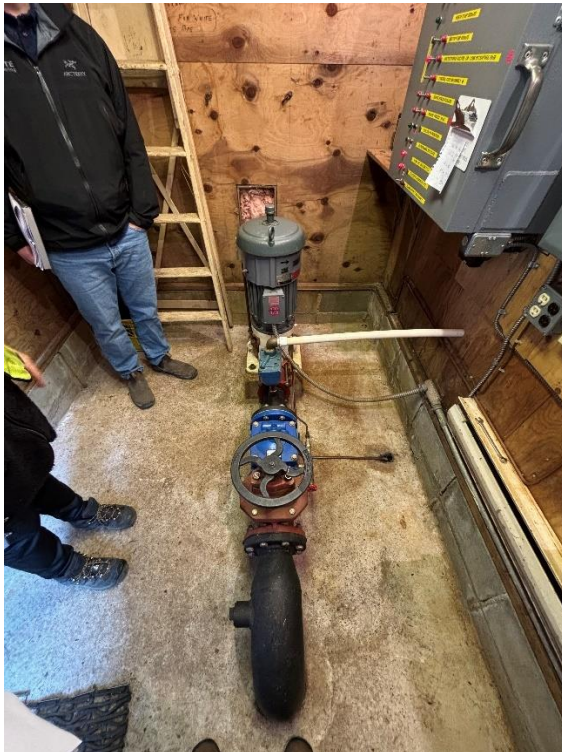
Figure 3 North Well House Piping Configuration

The well discharge piping consists of a 100 mm \emptyset steel discharge pipe with pressure gauge connections and an air release valve, which has a flange fitting connecting to a check valve. The check valve is a Valmatic Swing-Flex check valve, Model No. 504A. The check valve is flange connected to a Clow Gate Valve, also sized 100 mm \emptyset . The gate valve can be opened and closed with no sign of stress or resistance, and the pump was turned on to run during the condition assessment. The check valve appeared to operate as required, with no cavitation noises or vibrations apparent during the pump run. The gate valve is flanged to a welded steel reducer, upsizing the pipe into a 150 mm \emptyset bend, directing the discharge piping below ground. There are no signs of corrosion on any of the piping and equipment, and while the system is dated, it is all in good condition.

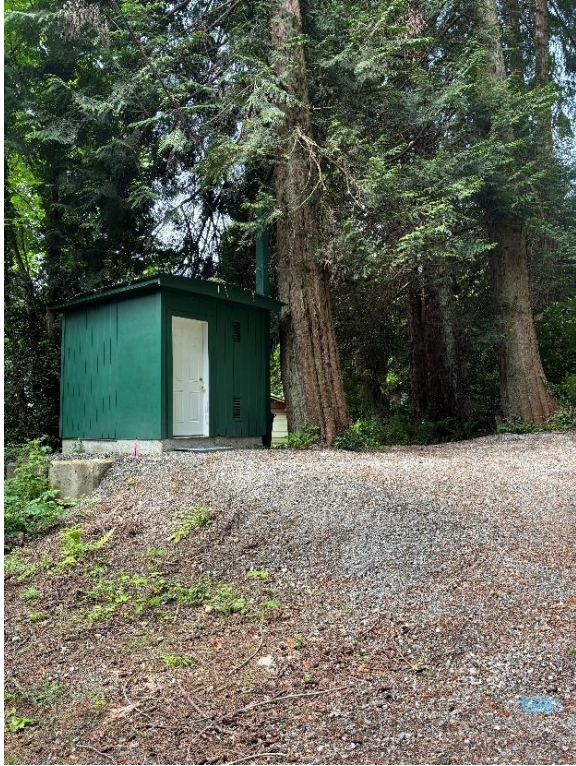
Figure 5 South Well House

The South Well House is in good condition and is designed similarly to Well House #1, appearing to not require any replacement or repair. It is situated on a concrete foundation pad surrounded by vegetation and trees with a gravel parking pad in the front. Approximately one maintenance vehicle can be parked at the front of the well house. There is no available outdoor lighting on site. The surface grading is sloped to pool water away from the well head. There is no fence protecting the well house, but the door is kept locked, providing a measure of site security.

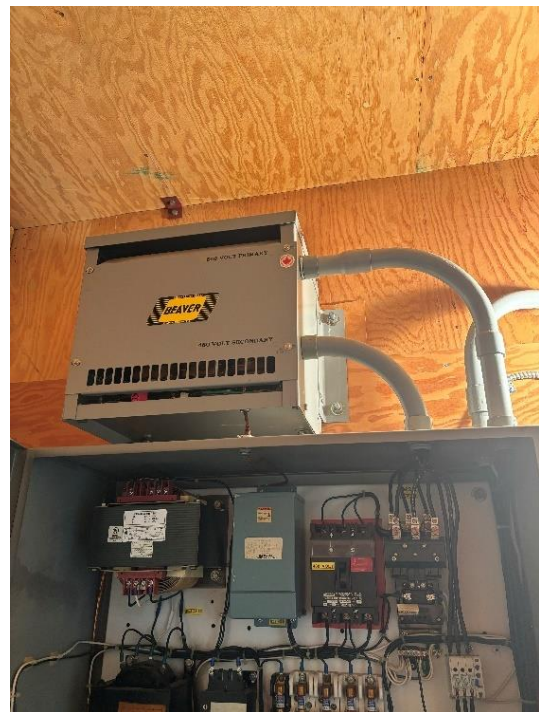
Figure 8 South Well House Electrical

The motor and power cables are not continuous from within well to within the kiosk, the receptacles are not ground fault interrupters (GFI), and the pump is not equipped with an amp meter. However, there seems to be no obvious code violations. The pump is equipped with an hour runtime meter. Like the North Well House, there appears to be no signs of corrosion, just obsolete electrical equipment.

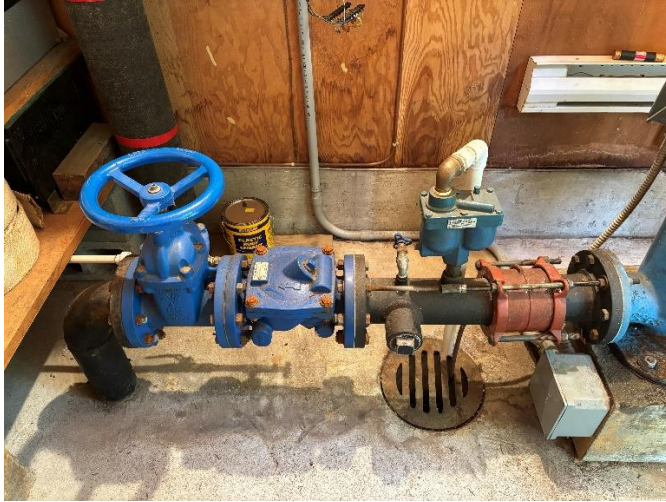
Figure 9 South Well House Piping

No cavitation noises were made apparent during the pump run. A slight bend is visible in the aboveground piping however it is within tolerance. There are no signs of corrosion on any of the piping and equipment, and while the system is dated, it is all in good condition.

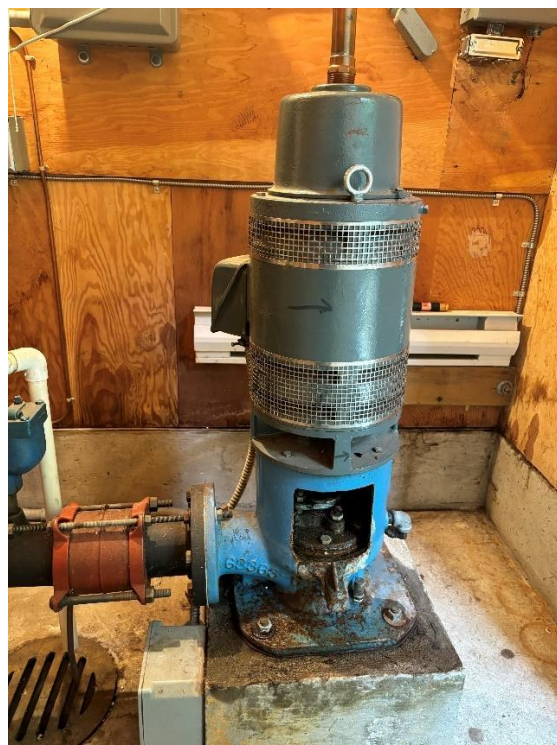
Figure 12 South Well House Pump

The well head appears to be in good condition and is encased in concrete. The encasement is in good condition and is raised above grade to direct water pooling away from the well head. The well head is sealed and equipped with a SIMFLO vertical turbine pump, Model No. SM6C-4 (Serial No. 104988).

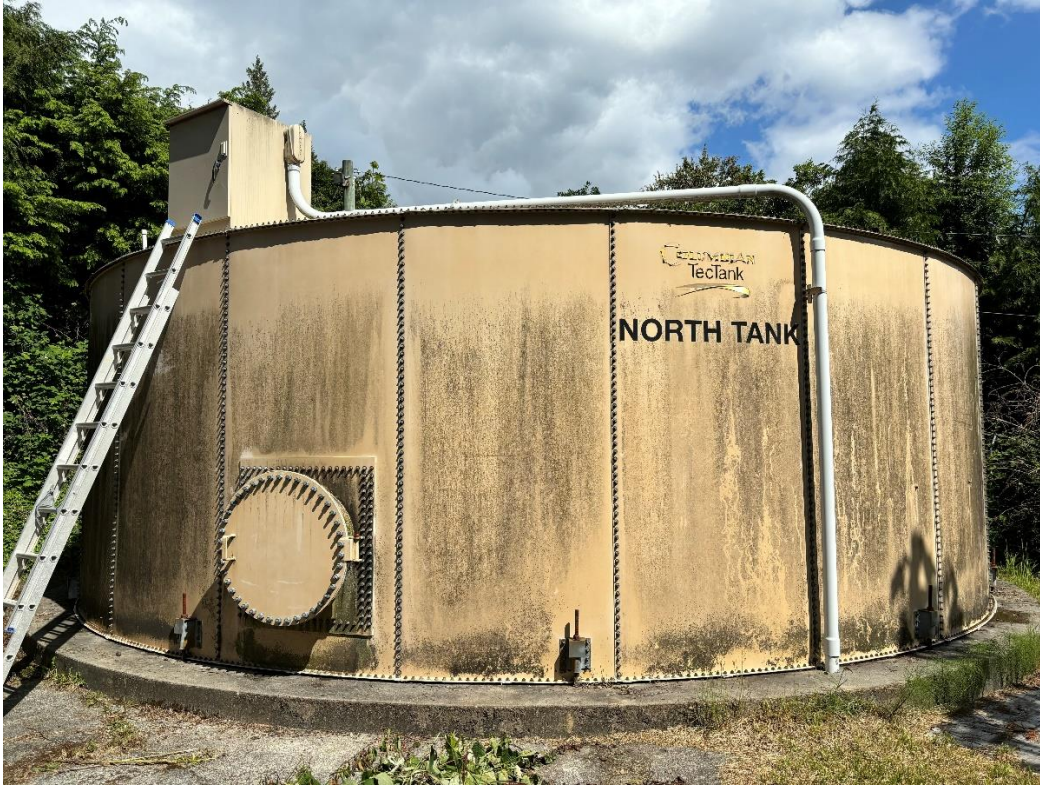
Figure 13 North Tank

The exterior of the tank is in good condition, with no visible signs of paint flaking or corrosion on the bolts. There is minor moss growth on the exterior, and small debris on the roof of the tank, but overall there is nothing concerning from a visual perspective. The valve chamber is in good repair, however a visual inspection of the chamber itself proves that moisture and organic material are freely entering the chamber, and the wooden cover is showing signs of rot due to the high presence of moisture.

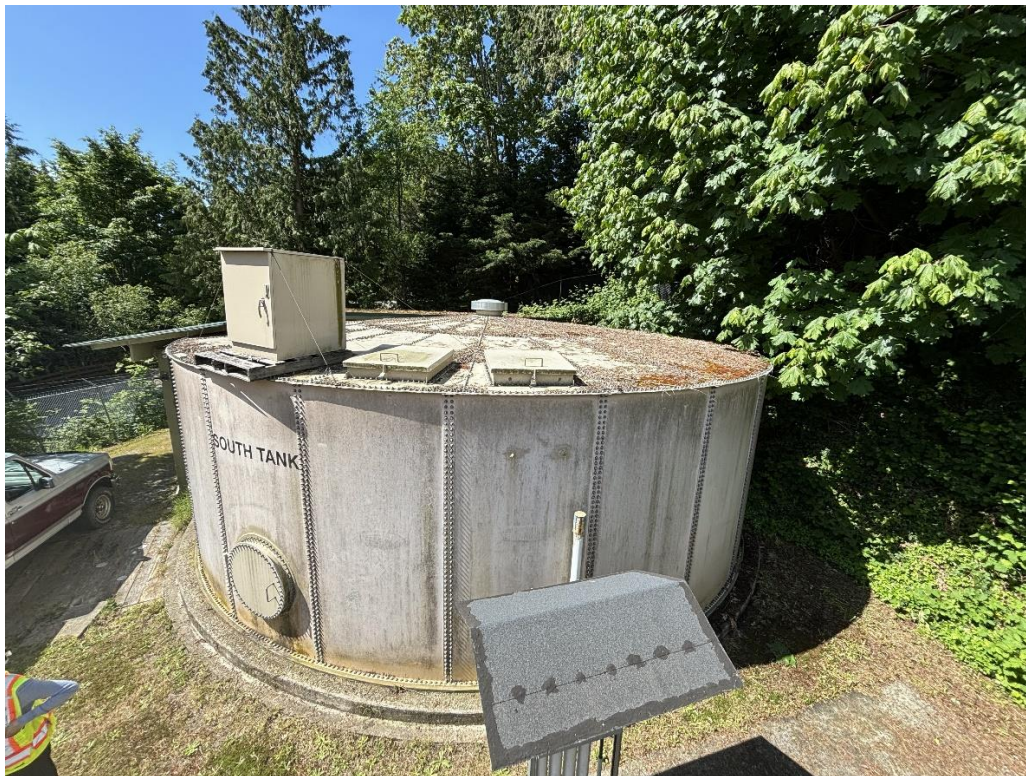
Figure 14 South Tank

The exterior of the tank shows signs of age and corrosion, with moss forming over the steel exterior. All bolts appear in good condition, with no signs of failure. The valve chamber is in good repair, however a visual inspection of the chamber itself proves that moisture and organic material are freely entering the chamber, and the wooden cover is showing signs of rot due to the high presence of moisture. The act of opening the tank is not easily done by one person, and the process of removing each individual plank of wood to access the chamber, then fitting them back may prove to be inefficient and potentially a safety issue if not correctly placed back.
