SUBJECT: HOPKINS LANDING WATERWORKS DISTRICT CONVERSION OPTIONS

**Hopkins Landing Waterworks District
Water System Condition Assessment**

Appendix B – Site Photos

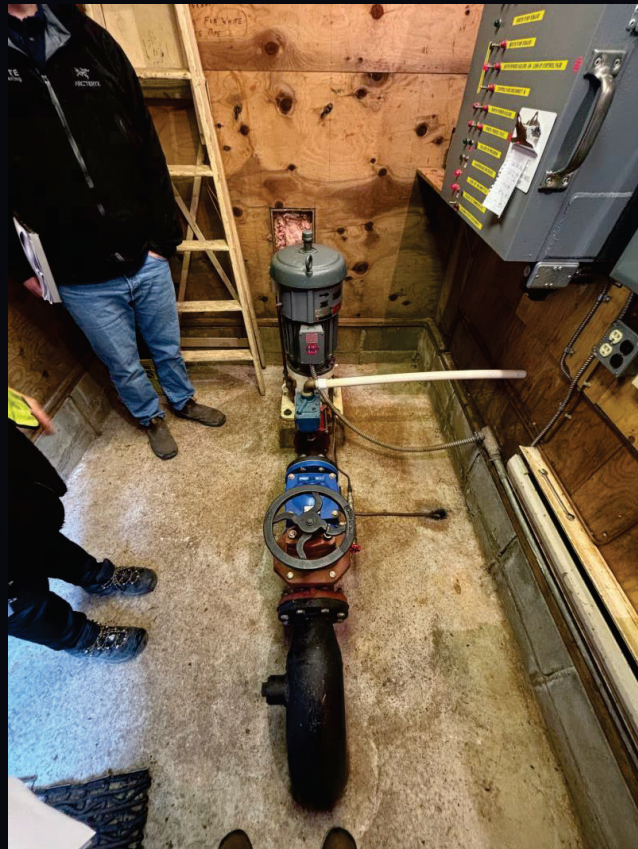
North Well Mechanics

- Water quality meets Canadian Water Drinking Guidelines
- Can supply about 24.6 L/s
- Aging infrastructure does not currently meet Groundwater Protection Regulations
